## IMPROVED DESIGNS FOR ISOCON CAMERAS IN HERTR SYSTEMS

BY JOSEPH J. STAFFORD  
J. STAFFORD ASSOCIATES FOR  
RESEARCH AND TECHNOLOGY DEPARTMENT

7 JUNE 1985

### NAVAL SURFACE WEAPONS CENTER

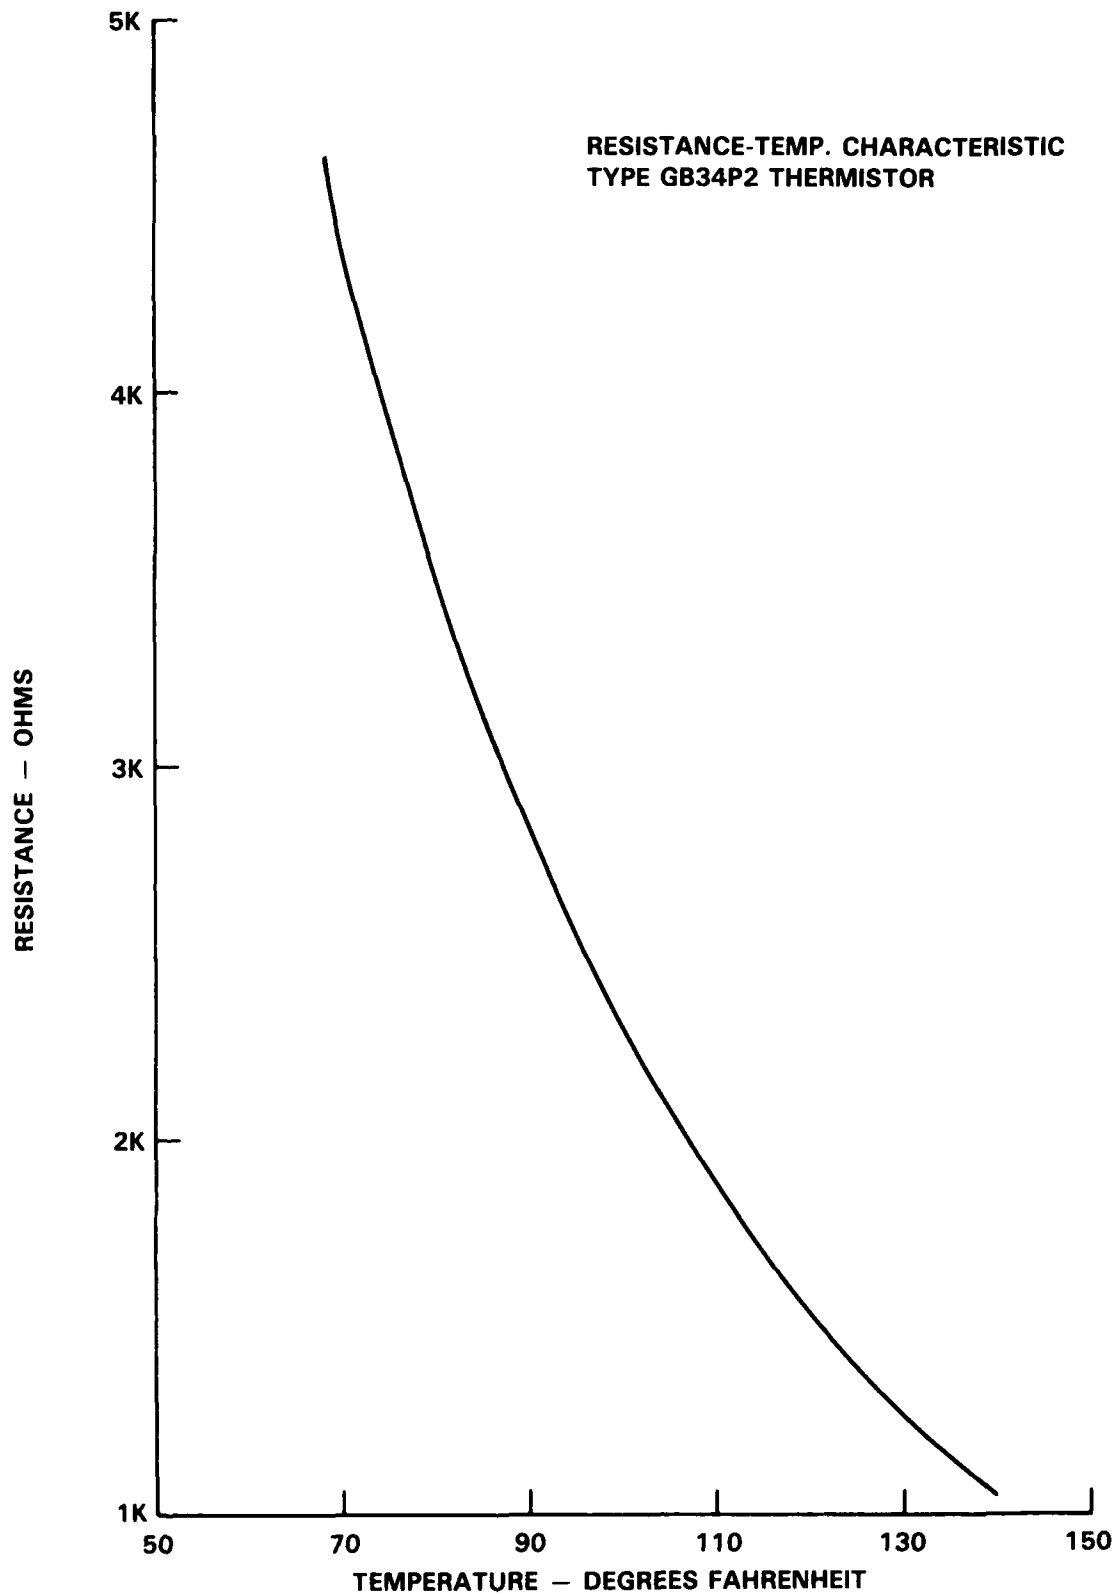
FIGURE 1. RESISTANCE/TEMPERATURE CHARACTERISTIC OF THERMISTOR

a. The deflection yoke, or deflection coil, lies immediately above the camera tube and provides the physical socket for the shoulder pins located on the rear of the head of the Isocon tube. In addition, the rear of the Isocon tube is supported on rubber snubbers located at the rear of the deflection yoke. In the region of the shoulder socket and extending into the space separating the socket from the tube, a thermistor is located. A thermistor is a thermally sensitive resistor having a negative temperature coefficient characteristic. The calibration curve for the thermistor type used in the Isocon yoke is shown in Figure 1.

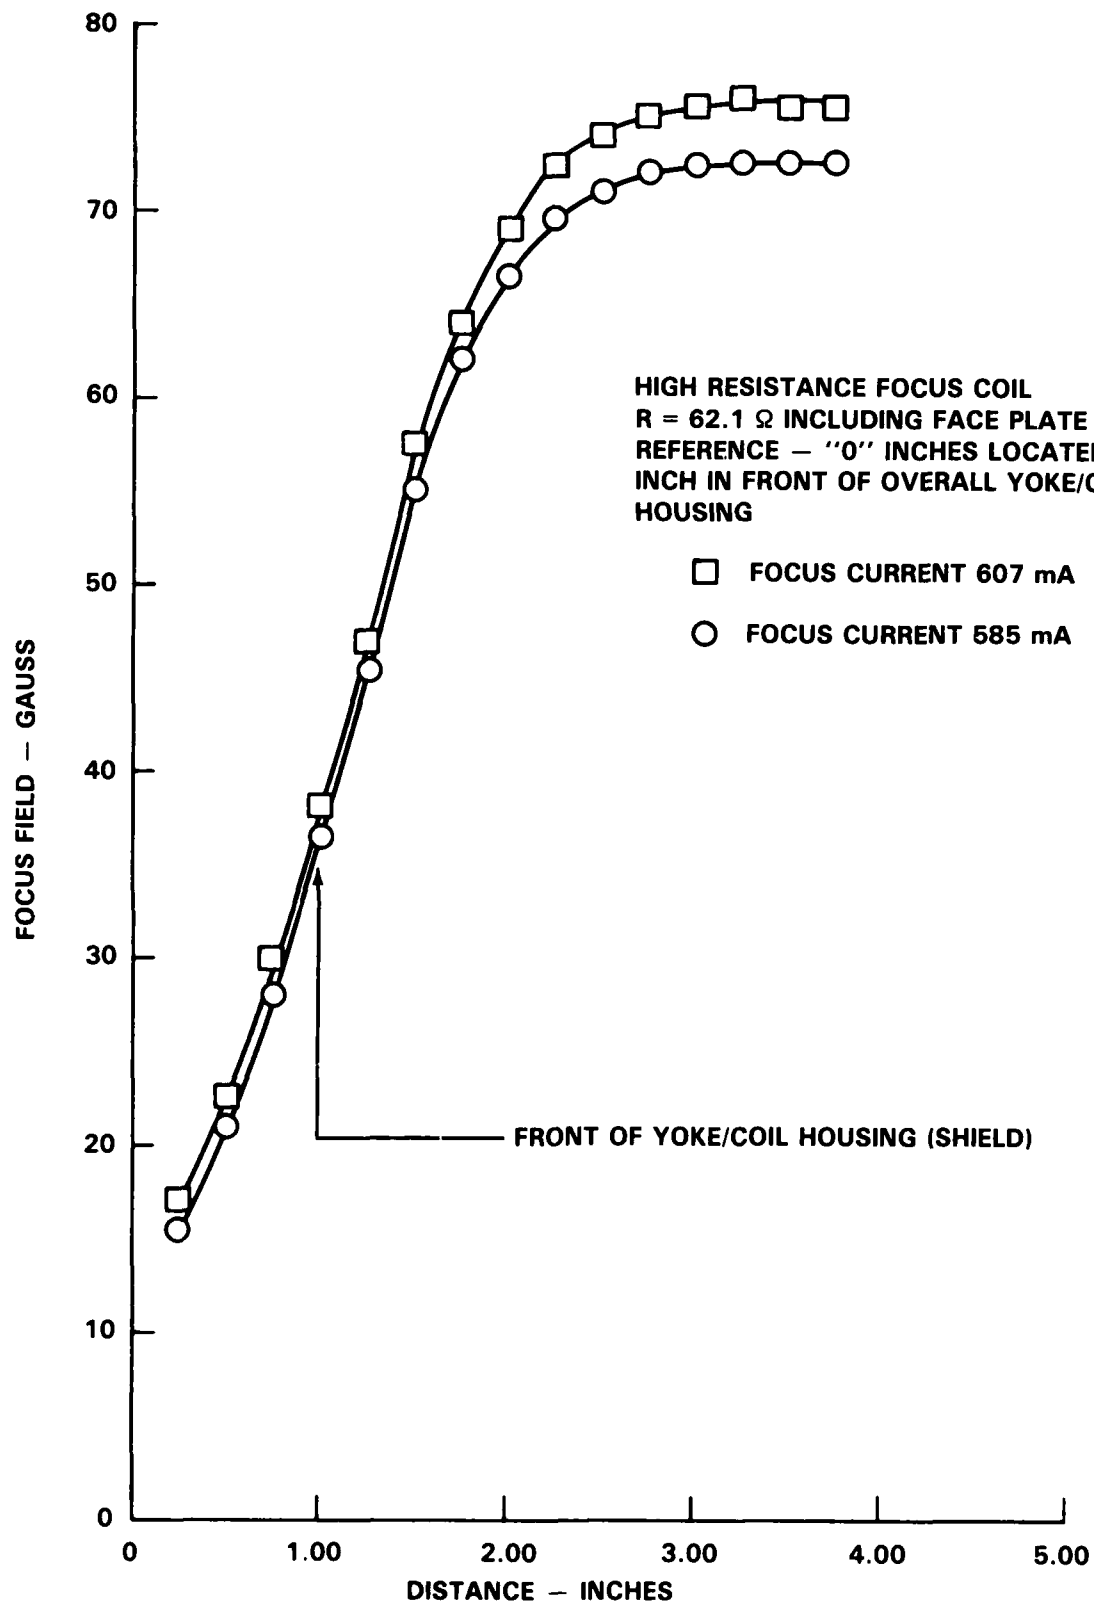
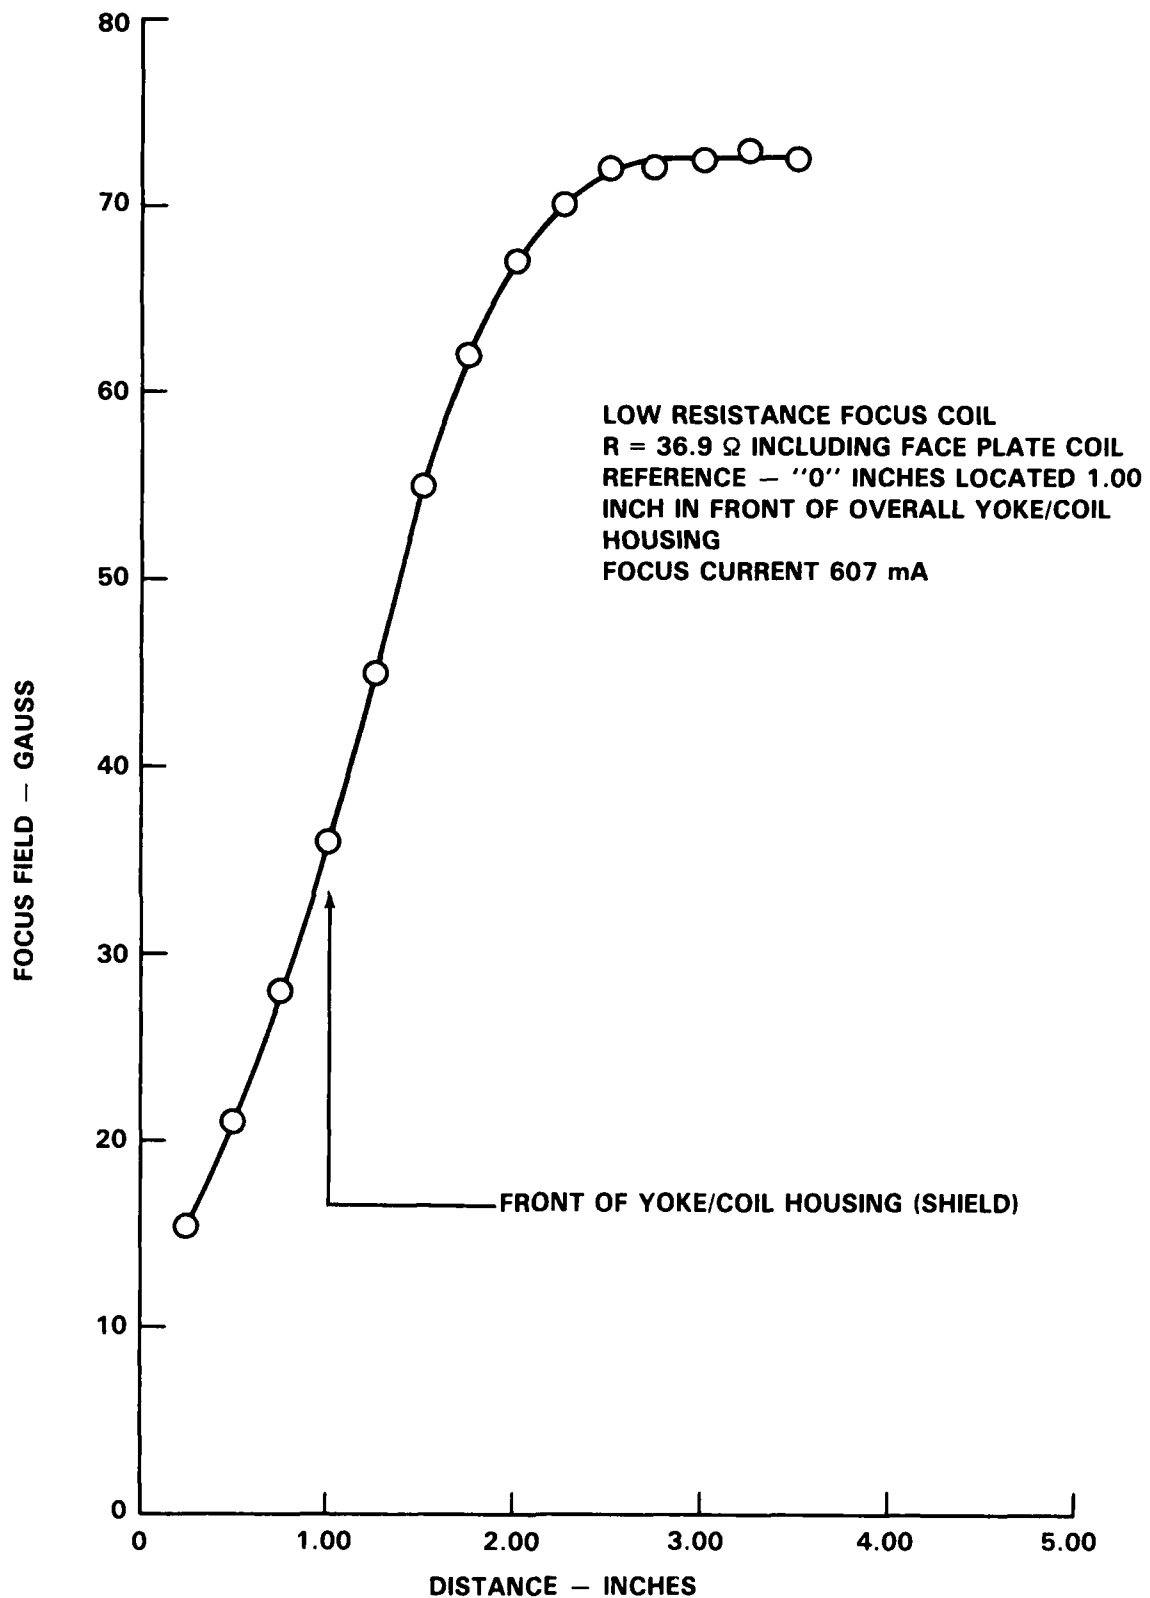
in the rear portion of the deflection yoke. The same faceplate coil was used in all measurements, shown in Figures 2 and 3, for both main focus coils. The resistance of the faceplate coil is typically 2 ohms.

a. Remove the present focus coil assembly and replace it with a similar unit having a lower series resistance. As shown in Figures 2 and 3, they can be made magnetically equivalent.

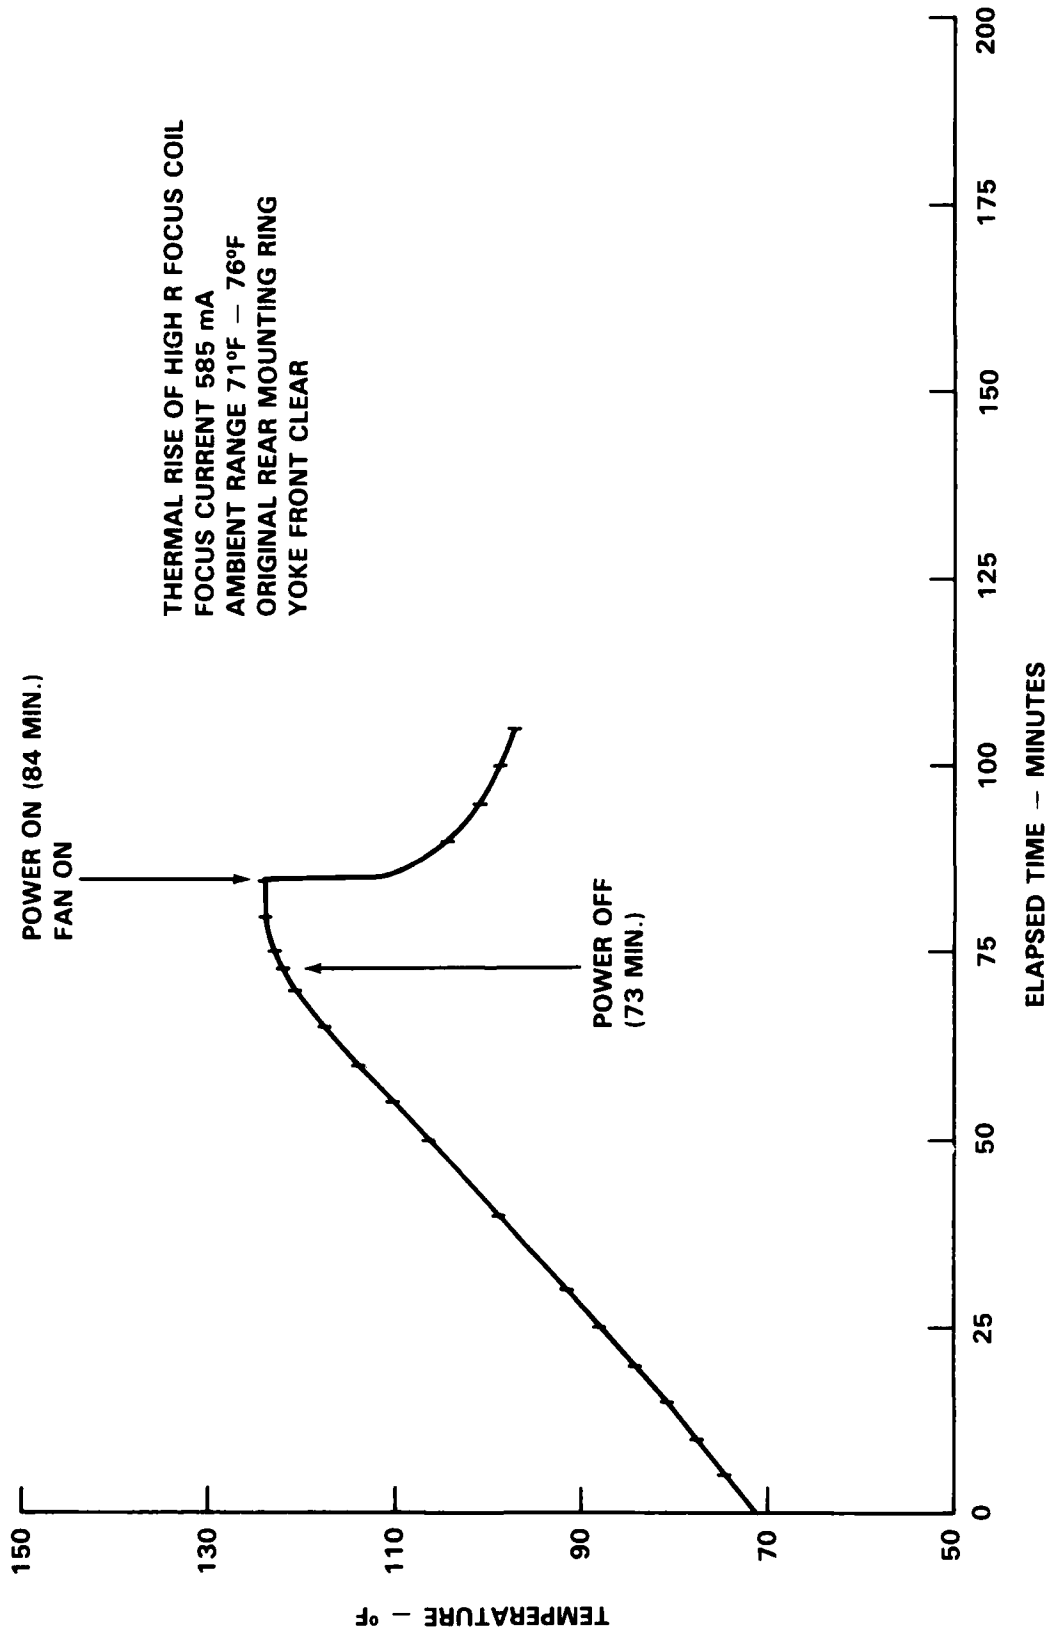
FIGURE 4. THERMAL CHARACTERISTIC - HIGH R COIL

Several characteristics are to be noted in the accompanying Figures 4,5,6,7,and 8. Comparisons of Figures 4 and 5 measure the effect of a slightly open and a very much open yoke assembly. The slightly open condition is established with the Canon lens. Optical focus with the high resistance focus coil allowed sufficient clearance to between the lens and the tube to allow cooling air to pass into the yoke in sufficient quantity to cool the thermistor. The setup in Figure 4 is representative of the current situation in the HERTR system. Note the approximately 70-80 minutes required to bring the thermistor to 122 degrees.

Compare Figures 4 and 6. Now the lens opening is setup very clear and the rear mounting ring is changed to a very open condition. Note the very much more rapid drop in temperature after application of cooling air and the narrower the difference between ambient and thermistor temperature. The ambient room temperature was actually lower for the test measurements shown in Figure 6

than those shown in Figure 4. Other system measurements had been undertaken prior to the beginning of taking data for the run described in Figure 6 and the camera hadn't been allowed to come to a fully cooled down condition.

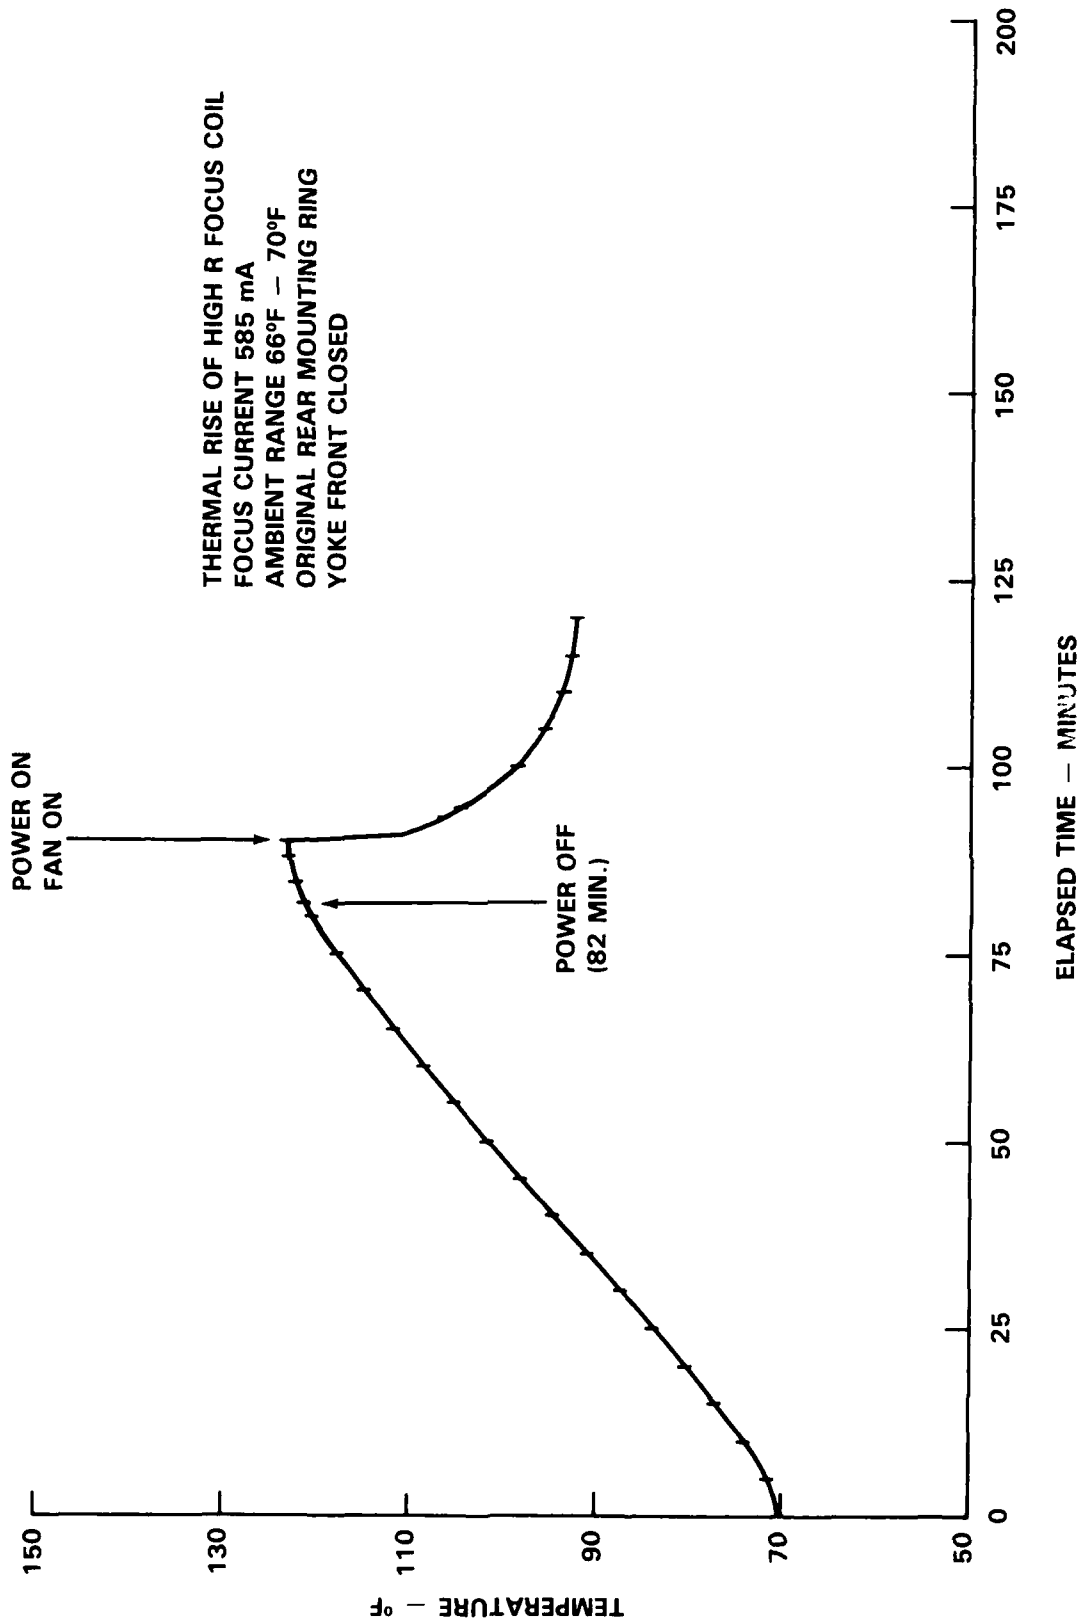
FIGURE 5. THERMAL CHARACTERISTIC - HIGH R COIL

Compare Figures 5 and 7. The lower resistance focus coil was used during the run described in Figure 7. This coil required that the lens, the Canon, completely block the deflection assembly front opening in order to achieve optical focus. The long, relatively slow cool down rate indicates that the air flow is partially blocked. This condition could be relieved if the lens was only slightly defocused. The camera assembly was designed in such a way that the lens focus was controlled with a differential screw. Differential screw action was such that the lens moved just under .015 inches per revolution or turn. Less than 1/2 turn would cause the temperature drop to increase significantly. From a just open condition as just described to a fully closed condition as was the initial condition, the temperature would actually rise rather than continue to fall. Now the heat input rate exceeded the cooling rate. Also note the longer period required to bring the thermistor to 122 degrees.

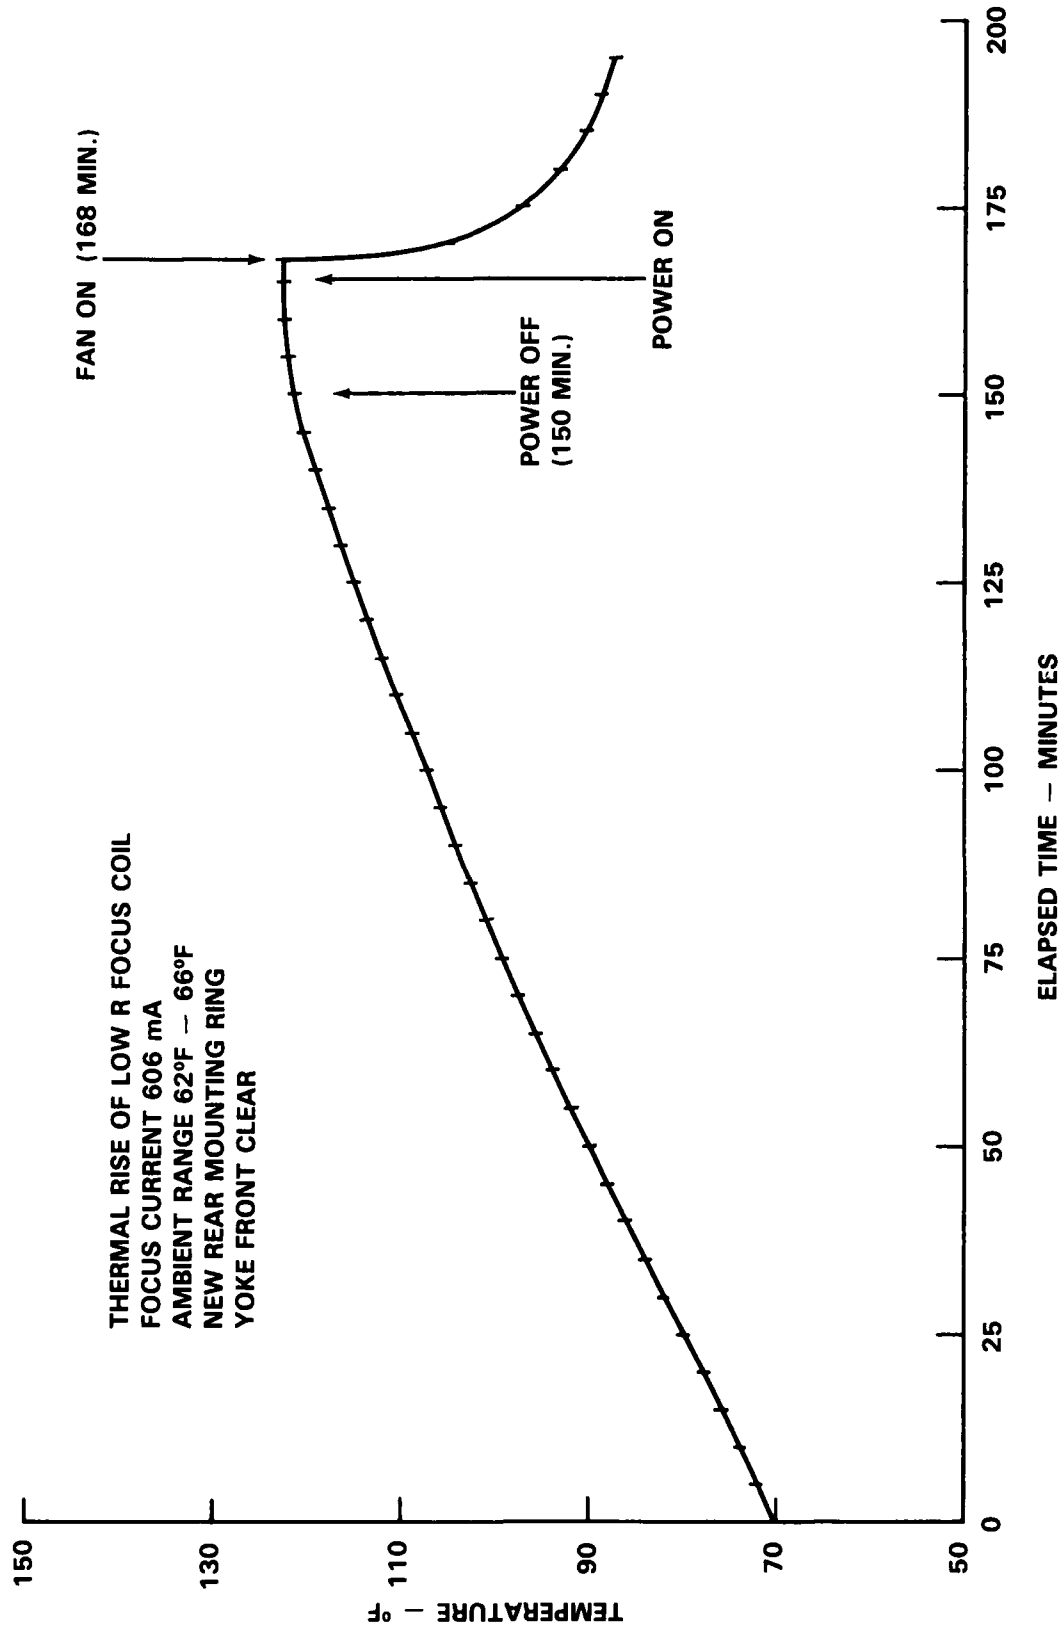
FIGURE 8. THERMAL CHARACTERISTIC - LOW R COIL

Compare Figures 4 and 8. Now the focus coils are different, and the rear mounting rings are different. The time required to heat the thermistor without the benefit of cooling is more than doubled, the rate of cooling is increased, and the asymptotic temperature is closer to room temperature. The configuration represented in Figure 8 is the appropriate design for this camera.
